## Examining the Structure of Mill Rolls Made of 9X2MΦ and 8X3CΓΦ Steels Using the Ultrasonic Method for Quality Control

A. V. Belonosov<sup>a</sup>, O. A. Chikova<sup>b</sup>, V. V. Yurovskikh<sup>a</sup>, and D. S. Chezganov<sup>c</sup>

<sup>a</sup> *Uralsmazavod, Yekaterinburg, Russia*

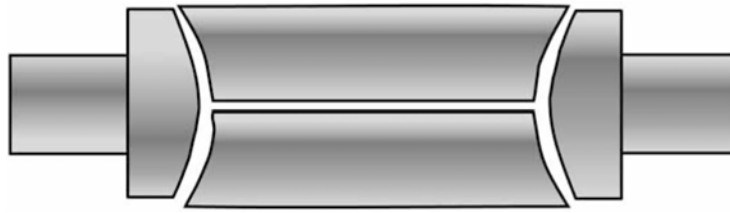
Production practice shows that the presence of these defects is the main cause of faults in rolls from a reversing mill. Figure 1 shows the fracture diagram of a 8X3CΓΦ steel roll that failed after the rolling of over 19000 t of metal during a half year of operation. The barrel of the roll was disintegrated into a few pieces; fracturing was accompanied by local delaminations of the working layer. The middle part of the barrel ~ 800–900 mm long was disintegrated along the central axis into two pieces. Two nuclei were found

Fig. 1. The fracture diagram of the roll.

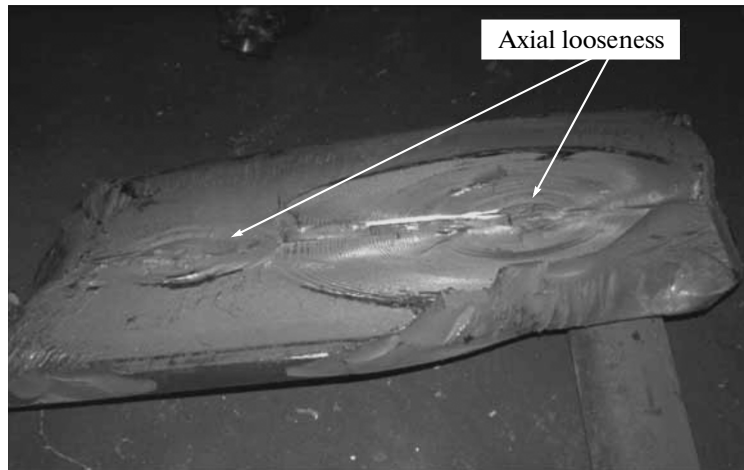
Fig. 2. An image of fracture nuclei of the roll.

in the longitudinal fracture of the barrel and fatigue fracture zones propagate from these nuclei (Fig. 2). The fracture of the roll shows zones with coarse-grained and fine-grained structures.

The type of the fracture nuclei of the roll (Fig. 2) is indicative of the presence of a dendritic or slaty fracture [5]. The cause of these types of fracture is an increased concentration of nonmetal inclusions that are arranged as strips after rolling. In steel articles, nonmetal inclusions such as oxides, sulfides, and silicates occur when a refractory material enters a liquid metal or agglomerates of deoxidizing products. This type of fracture (Fig. 2) can easily be confused with the fibrous structure that is intentionally formed in steels that are used to produce spring plates or springs by additional alloying with manganese and silicon.

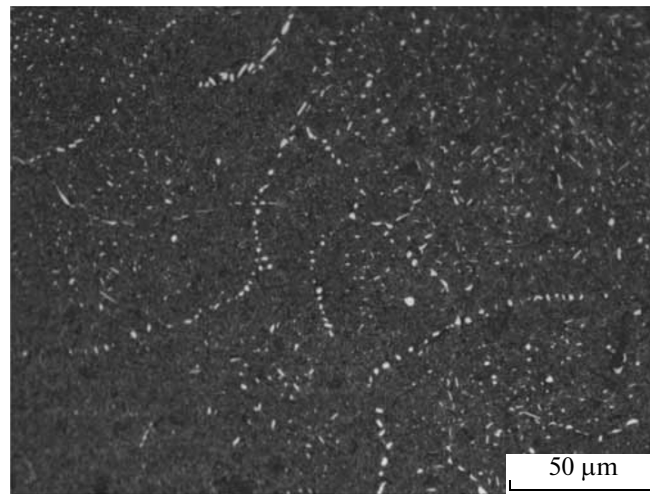
Specimens were taken from the roll fracture zone and their microstructure was examined. Qualitative metallographic analysis has shown the presence of nonmetal inclusions: the granularity is four points for sulfides and five points for complex oxides according to GOST 1778–70 in the fatigue fracture zone in samples taken from the specimen core. The etching of the specimens has revealed the structure of lamellar and globular pearlite with a granularity of 2–4 points according to GOST 8233–56 in samples taken from the core. It is noted that the structure of the core metal is inhomogeneous due to the presence of lamellar and globular pearlite with various granularities [6]. Thus, in the core of the roll barrels, axial looseness occurs that is the nucleus of the origination and propagation of cracks. The roll metal has a brittle structure due to the presence of carbides arranged as a network that is located along grain boundaries (Fig. 3). The presence of nonmetal inclusions favored the origination and expansion of fatigue fracture zones that propagated from the core to the surface of the roll, thus resulting in roll fracture.

Fig. 3. The carbide network located along grain boundaries.

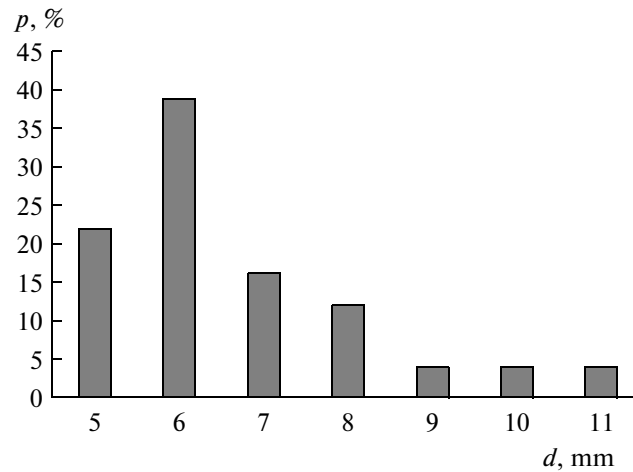
Fig. 4. The size distribution of discontinuity flaws.

to OST 24.023.33–86 and has an equivalent diameter of  $\varnothing 4.5$  mm and an occurrence depth of 120–350 mm. Numerous discontinuity flaws with a marginal size were also found in this zone (Fig. 4).

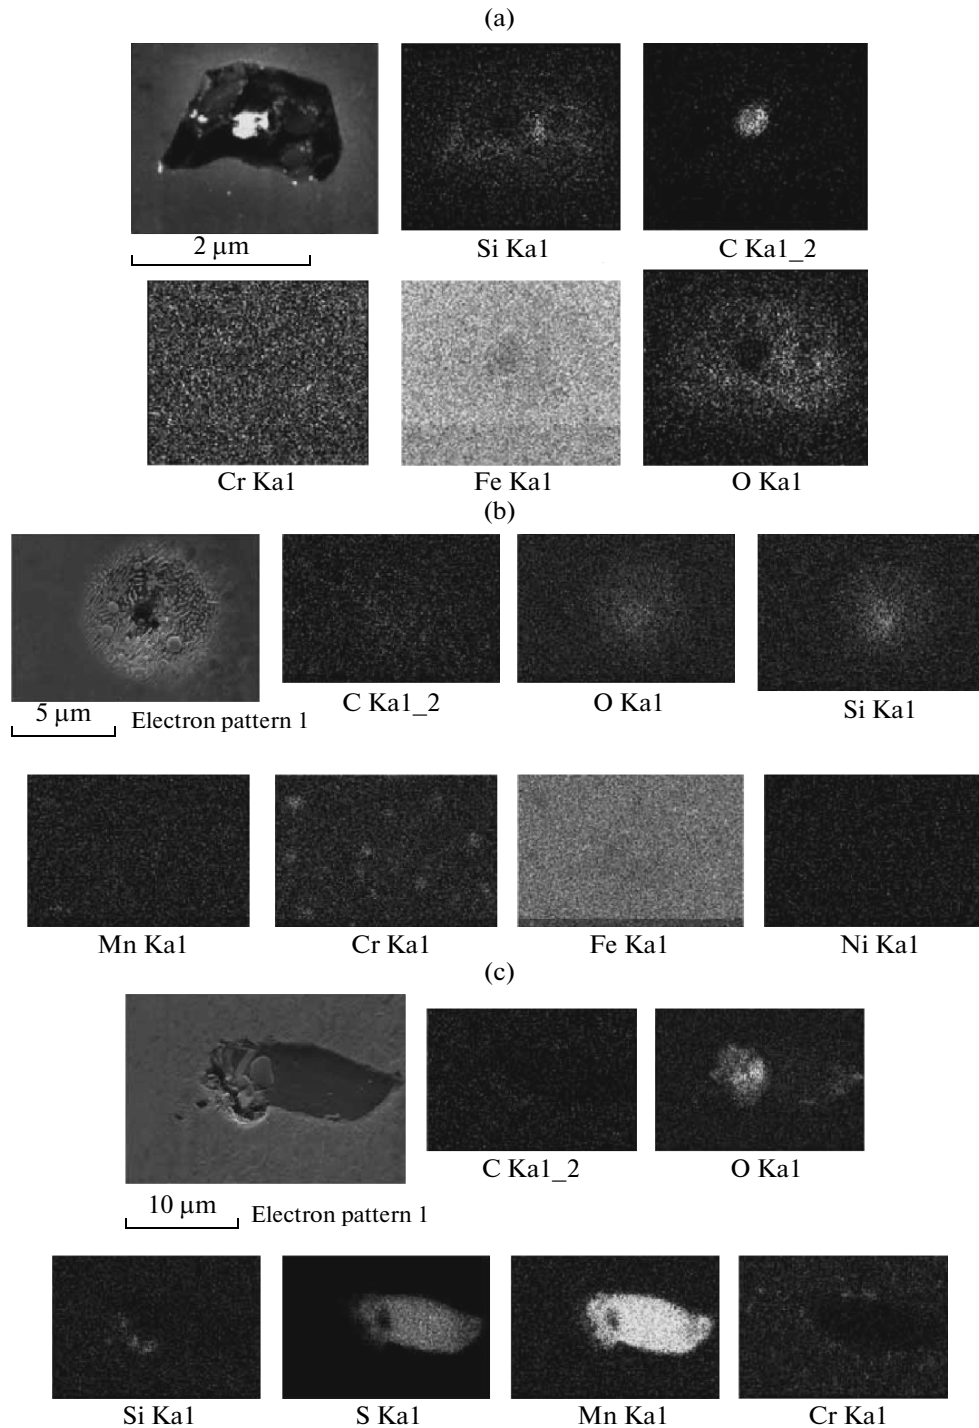
**Fig. 5.** The element distribution maps for (a) first-type, (b) second-type, and (c) third type inclusions.

ning electron microscopy using X-ray spectral microanalysis and electron backscatter diffraction. Element distribution maps for the inclusion zone were plotted (Figs. 5a–5c). Specimens that were taken from the roll defect zone in accordance with ultrasonic inspection data were examined. Qualitative metallographic analysis revealed three types of defects whose sizes are substantially smaller than those identified by ultrasonic inspection means. The characteristic size of inclusions from the first group was about 1 μm; these inclusions contained Si, O, and Al (Fig. 5a). Some of them contained globular regions enriched with carbon. These inclusions result from the entry of a refractory material into a fluid metal or agglomerates of deoxidizing products. Figure 5b shows the element distribution map for the second type of inclusions. The inclusions of the second type are spherically shaped and have a characteristic size of about 5 μm; these inclusions are uniformly distributed over the entire surface of the section. They are characterized by

increased concentrations of Si and O, which is indicative of their origin, i.e., they are particles of refractory materials. Inclusions of the third type are the largest; they have a complex structure and a characteristic size of about  $20\text{ }\mu\text{m}$  (Fig. 5c). The inclusions of the third type contain particles that are rich in Si and O in a surrounding that is rich in S and Mn [5]. These inclusions can result from the presence of low-melting Fe–FeO–FeS eutectic that is located along grain boundaries due to the presence of an excess amount of oxygen and sulfur in the metal. It is known that oxygen reduces the melting temperature of Fe–FeO–FeS eutectic [5]. Nonmetal inclusions whose elastic characteristics differ from those of steel cause the scattering of ultrasonic waves. As was noted in [7], scattering depends on the ratio between the wavelength and the size of a microdefect. It was shown by I.M. Lifshits and G.D. Parkhomovskii [8] that, at  $\lambda/d \sim 800$

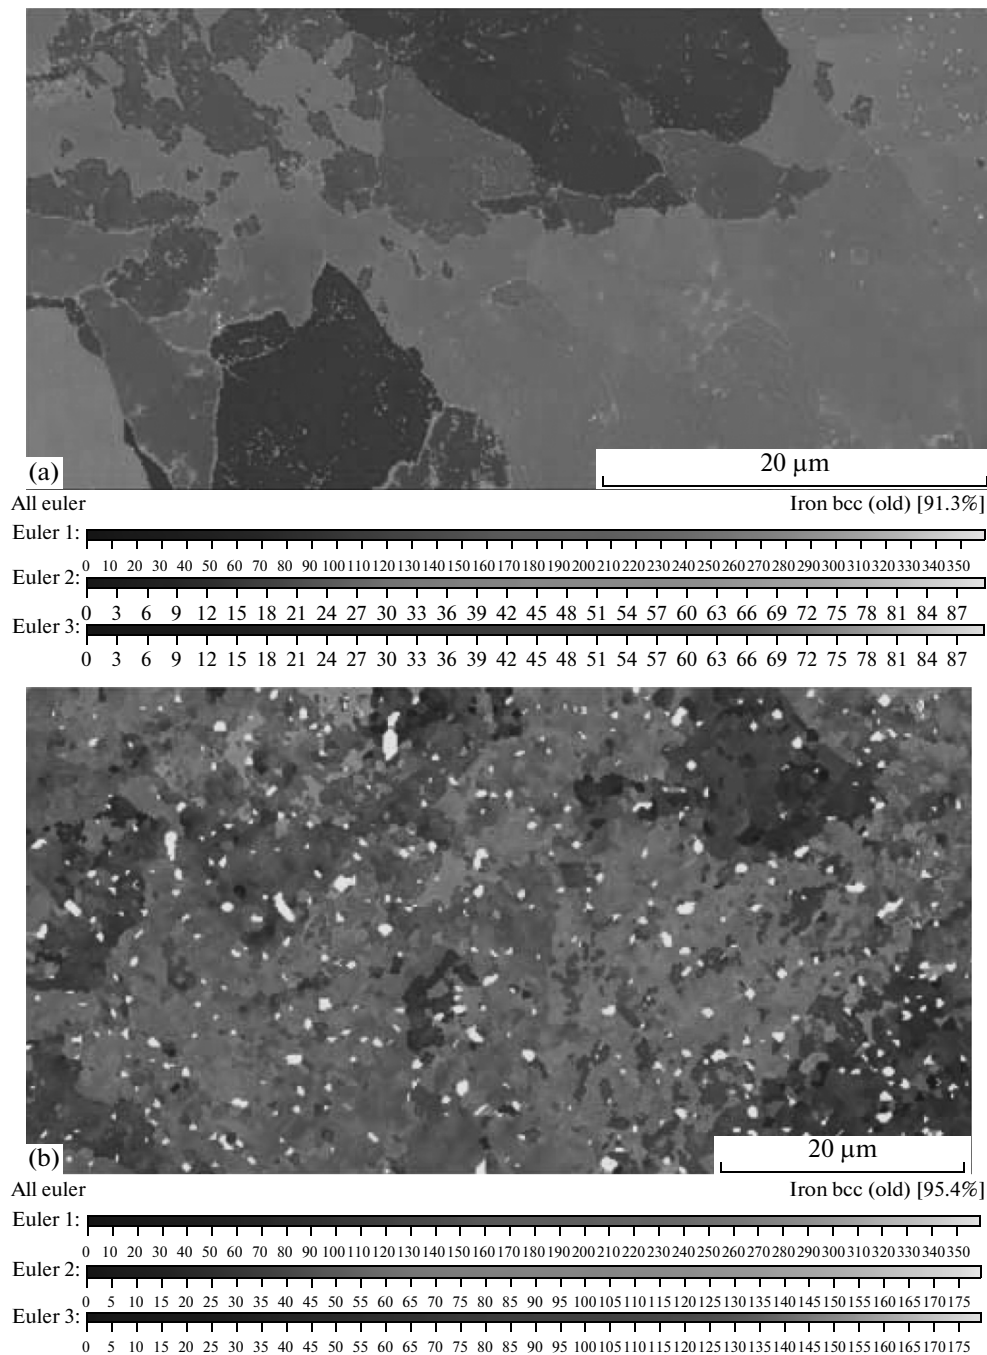
**Fig. 6.** The crystallite orientation map: (a) coarse crystallites and (b) fine crystallites.

The metallographic study of specimens of the 9X2MΦ steel taken from the defect zone using electron backscatter diffraction has shown that they have a polycrystalline structure. Figure 6 shows crystallite orientation maps (Euler angles). Areas with coarse-crystalline and fine-crystalline structures are found with a characteristic crystallite size of 10 and 1 μm, respectively (Figs. 6a and 6b). Misorientation histograms for coarse and fine crystallites are plotted (Figs. 7a and 7b). Correlated misorientations correspond to these orientations between the neighbor points and uncorrelated misorientations correspond to these orientations between the points randomly selected from a data set. The theoretical curve shows the expected result for a random data set. It can be seen that the correlated (blue) and uncorrelated (red) misorientations substantially differ from the theoretical curve and from each other. The difference between the uncorrelated misorientations and the theoretical curve is mainly due to pronounced texture. The correlated distribution histogram for fine crystallites shows a large number of low-angle boundaries, i.e., boundaries with a misorientation angle of less than 15 deg that are not seen in the uncorrelated distributions. The analysis of the misorientation angle histograms for coarse and fine crystallites shows that, in the first case, a large number of high-angle boundaries are found and, in the second case, a less pronounced texture of the material occurs. In both cases, the metal is textured, which must affect its acoustic characteristics [7].

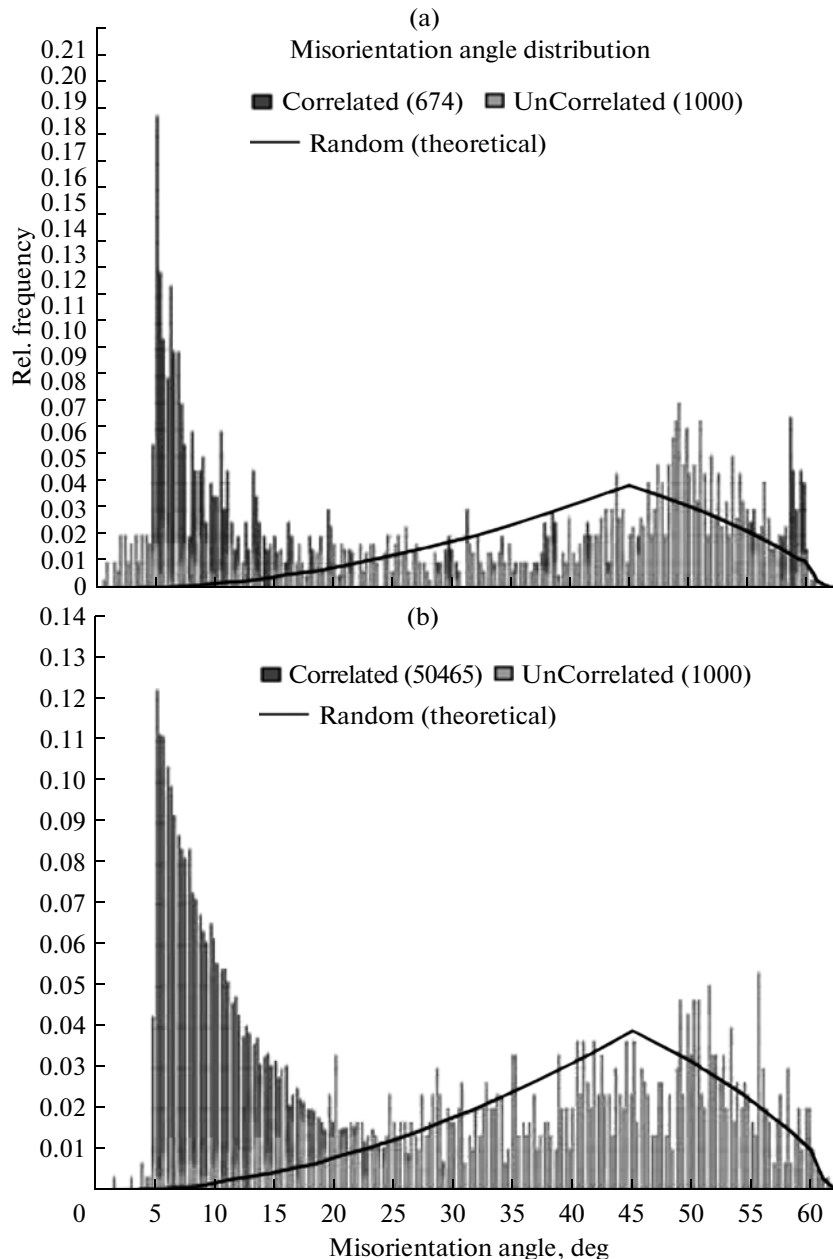
Fig. 7. The misorientation angle histogram for (a) coarse and (b) fine crystallites.

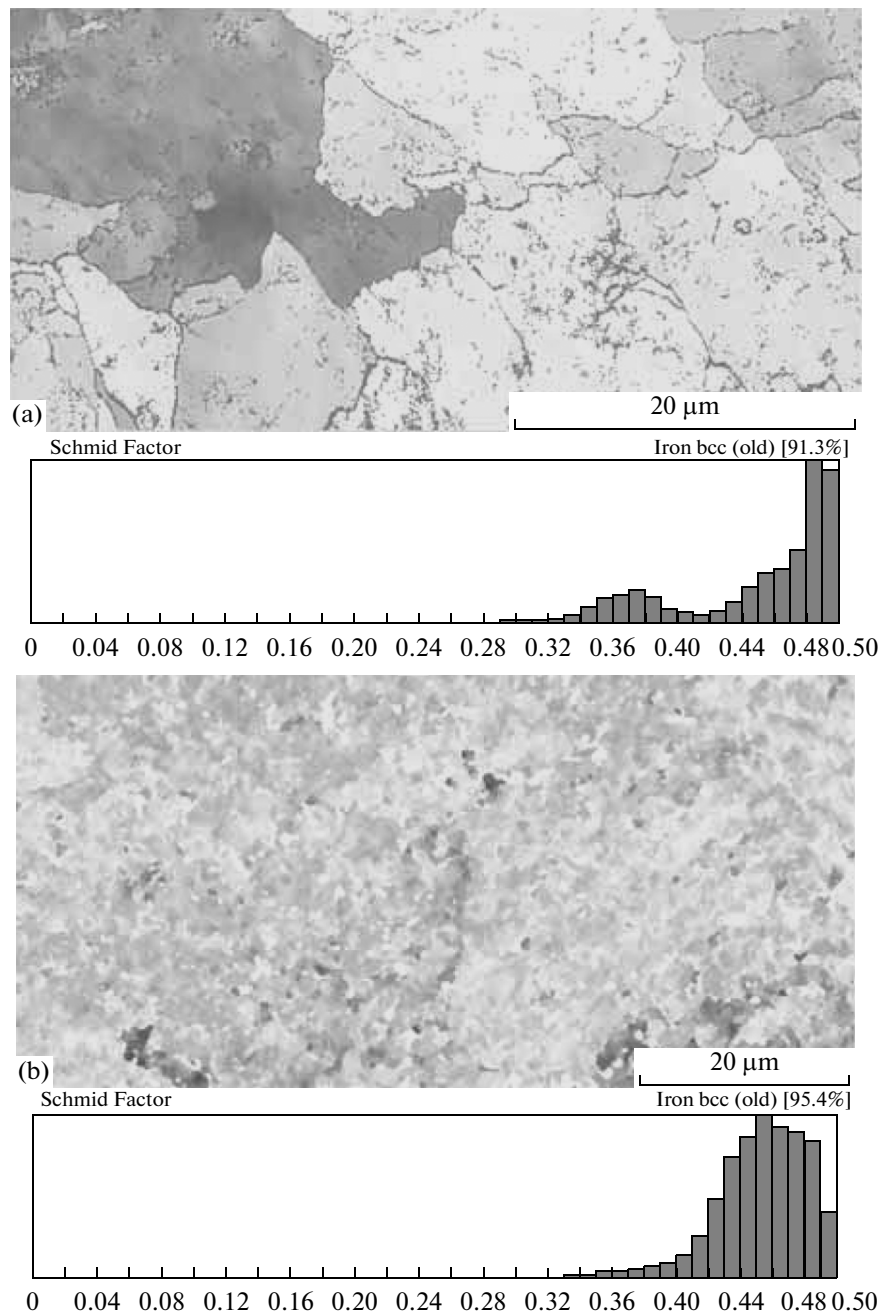
**Fig. 8.** The Schmidt factor map for (a) coarse and (b) fine crystallites.  $\{101\}\langle 111 \rangle$  deformation system, the loading direction is parallel to the  $OX$  axis. Bright areas correspond to higher values of the Schmidt factor. Under an external load, deformations will start to occur in bright grains and gradually propagate to dark grains.

The results of the analysis of Kikuchi diffraction patterns allowed us to plot Schmidt factor maps for deformation systems that are typical of αFe, i.e., {101}<111> and {211}<111> when the loading direction is parallel to the OX-axis. The Schmidt factor maps for the {101}<111> and {211}<111> deformation systems when the loading direction is parallel to the OX-axis are presented in Figs. 8 and 9, respectively. The following notation for the Schmidt factor maps is used: bright areas correspond to higher values of the Schmidt factor. Under an external load, deformations will start to occur in bright grains and gradually propagate to dark grains. It is known that the applied mechanical stress  $\sigma$  and the shear stress in the slip system  $\tau$  are related as follows:  $\tau = m\sigma$ , where  $m = \cos\lambda \cos\chi$  is the Schmidt factor or the orientation factor;  $\lambda$  is the angle between the slip direction and the deformation axis; and  $\chi$  is the angle between the normal to the slip plane and the deformation axis. The maximum value of the Schmidt factor is apparently 0.5 at  $\lambda = \chi = \pi/4$ . We note that for coarse crystallites the Schmidt factor histogram or the orientation factor diagram for the {101}<111> deformation system has two maxima (Fig. 8), which is indicative of the nonuniformity of the elastic characteristics, including the acoustic characteristics.

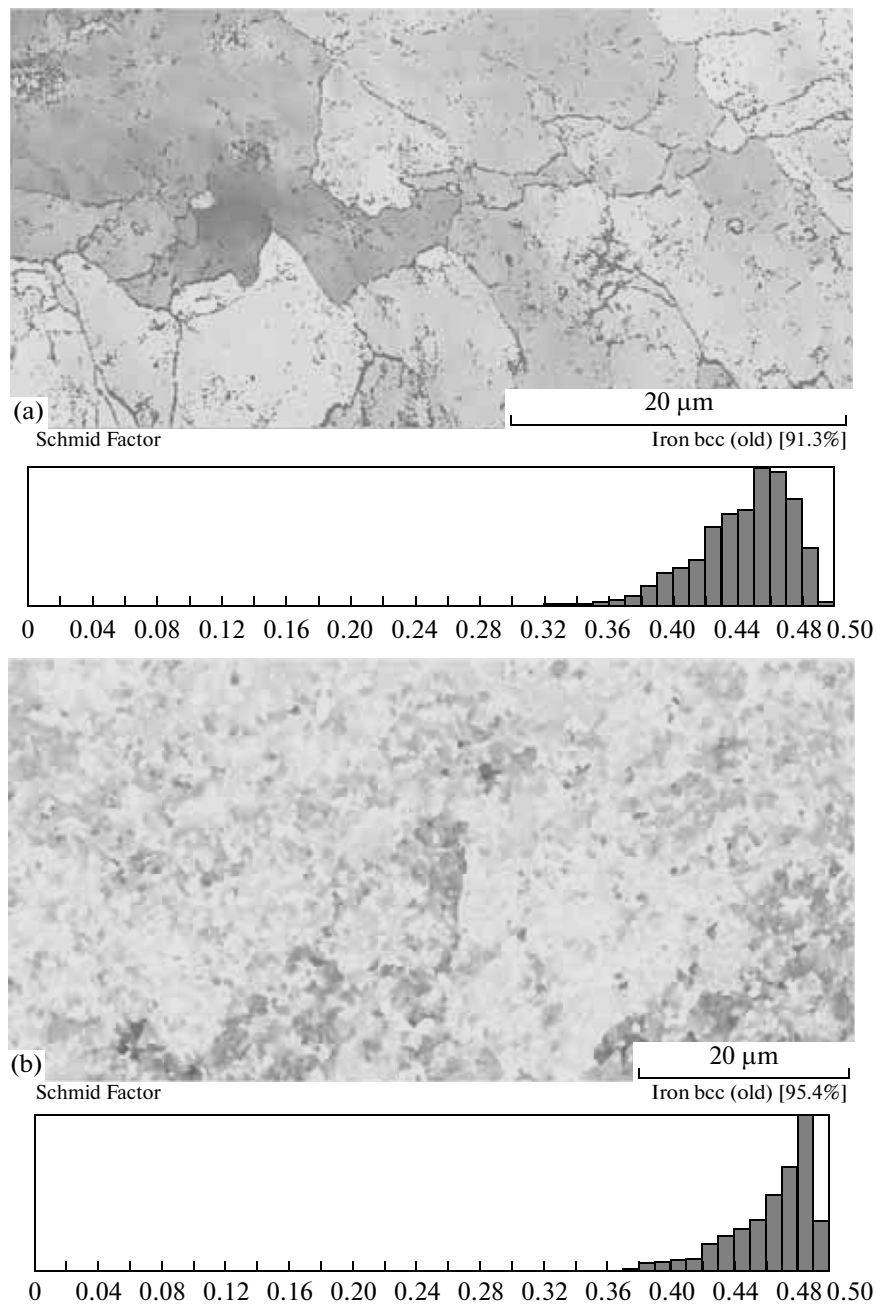
**Fig. 9.** The Schmidt factor map for (a) coarse and (b) fine crystallites.  $\{211\}\langle 111 \rangle$  deformation system, the loading direction is parallel to the  $OX$  axis. Bright areas correspond to higher values of the Schmidt factor. Under an external load, deformations will start to occur in bright grains and gradually propagate to dark grains.
